Asbestos Case Study

The Old Pump House - Lancaster

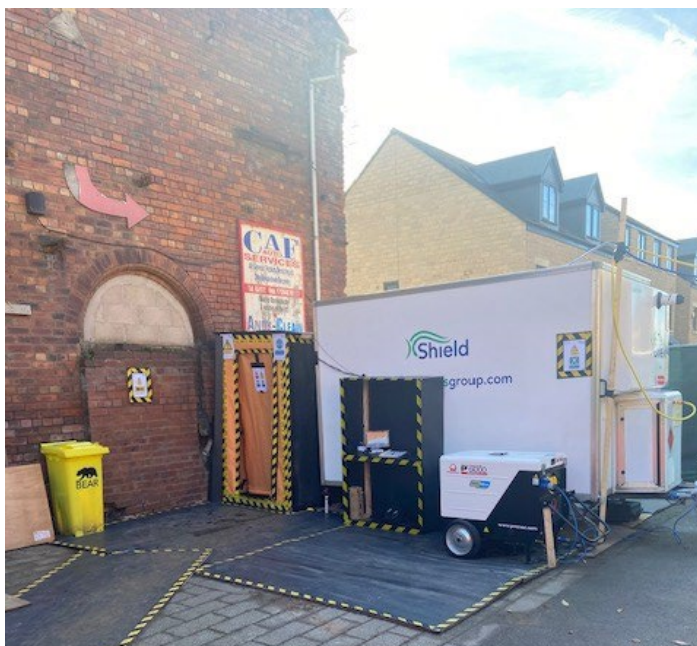
Overview of Enclosure Entrance and Decontamination Unit

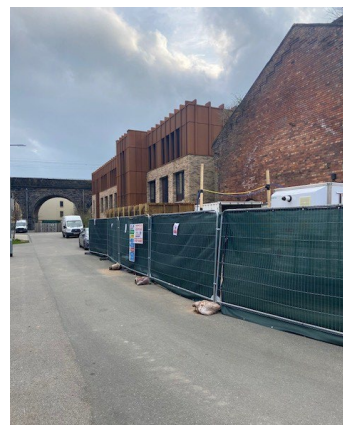
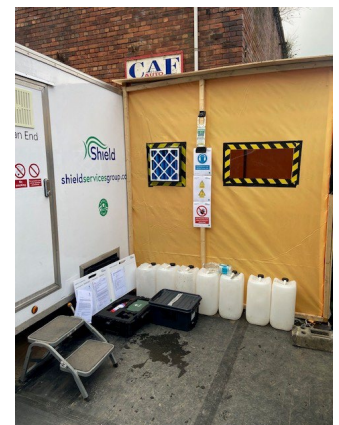
Challenging access and confined space working were encountered

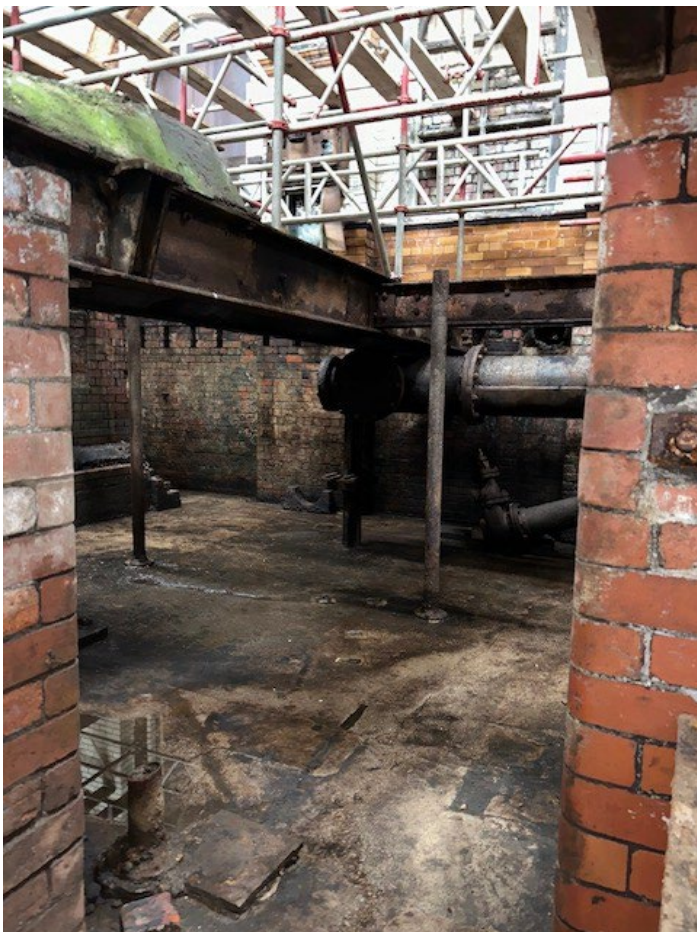
First Floor Area:

Post completion of works showing scaffolding structure to facilitate the forming of the enclosure to roof area.

View showing all removed former pumping services.

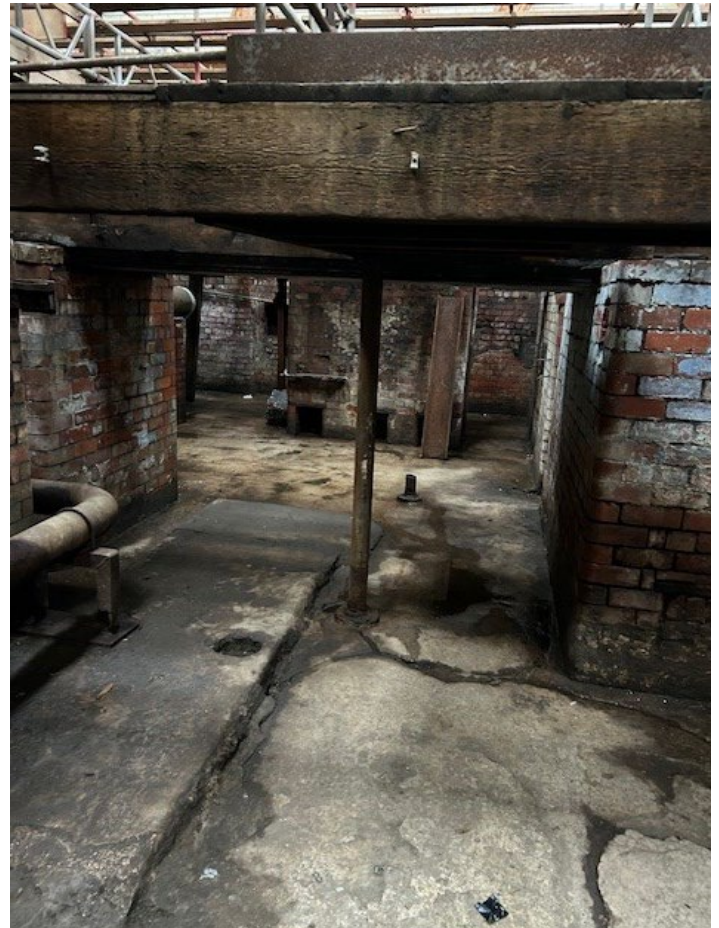
First Floor Area:

Post completion of our contracted works.

Further view showing all removed former pumping services.

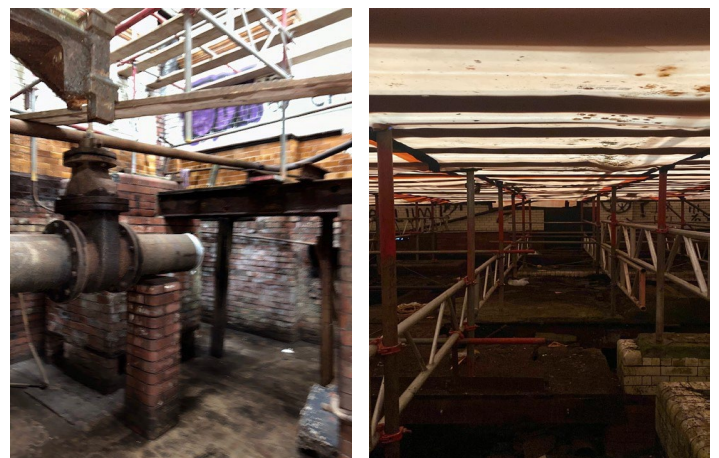
Further shot of first floor following the completion of works and image of pre-existing roof structure prior to the construction of enclosure and going live.
