# **Student Accommodation**

## **Bathroom Pod Refurbishment**

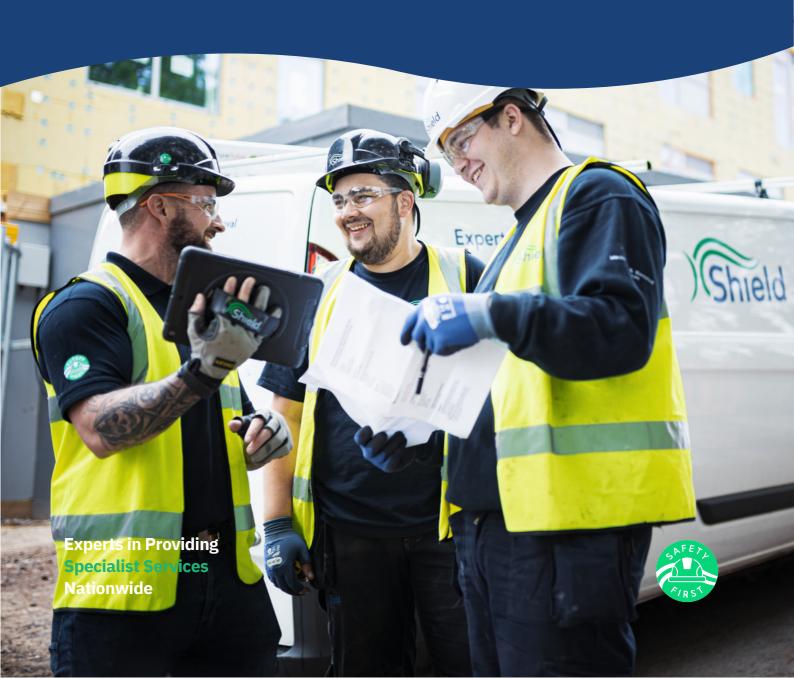
Shield recently completed a student accommodation bathroom pod refurbishment project, which involved a complete renovation of the bathroom area.

To achieve a perfect finish, two coats of suitable paint (with the right colour, gloss level, and texture) were applied by spraying the prepared surfaces. Additionally, the inset vinyl pad was removed from the basin/toilet floor for the modular shower and bathroom floors.

Next, the floor area was filled with a resin-based SL screed to flush it, and the margins were painted to match the bathroom walls with a 220CM Herculan topcoat. The inset area was then enlarged by 10mm and masked, and two coats of Herculan 220CM non-slip coatings were rolled on to achieve a consistent finish.
