Marine Case Study

Marine Services

Cargo vessel insulation installation

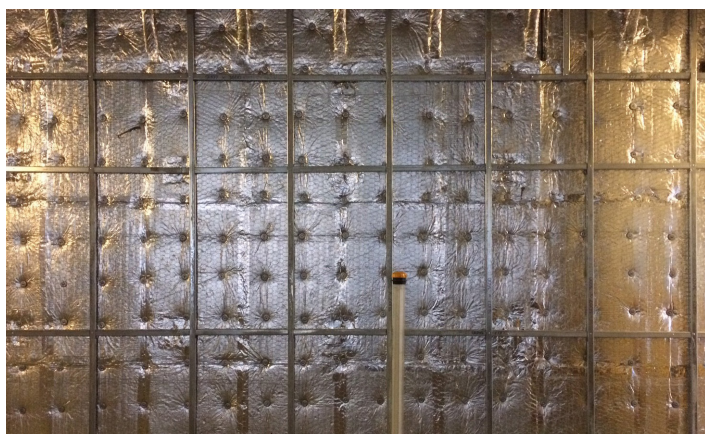
Completed A60 insulation Protocol applied to the newly installed steel bulkheads on two levels.

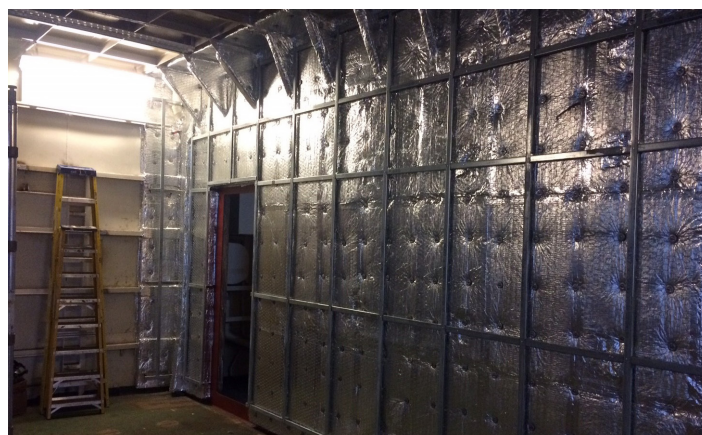
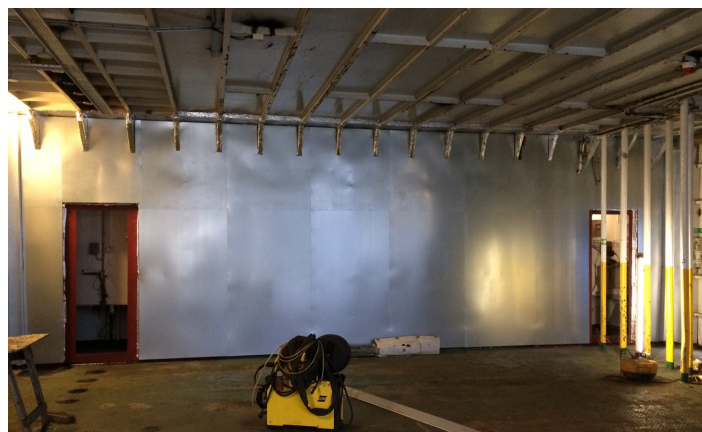
A60 doors were installed at port and starboard stations.

Note that the escape tunnels offer the crew safe egress and disembarkation to and from the main deck via two newly installed A60 doors.

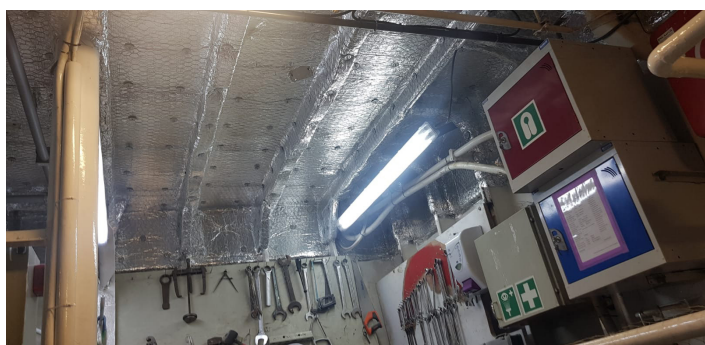
Cladding covering the insulation was installed as a separate application to prevent flammable fluid ingress and to offer mechanical protection against damage.

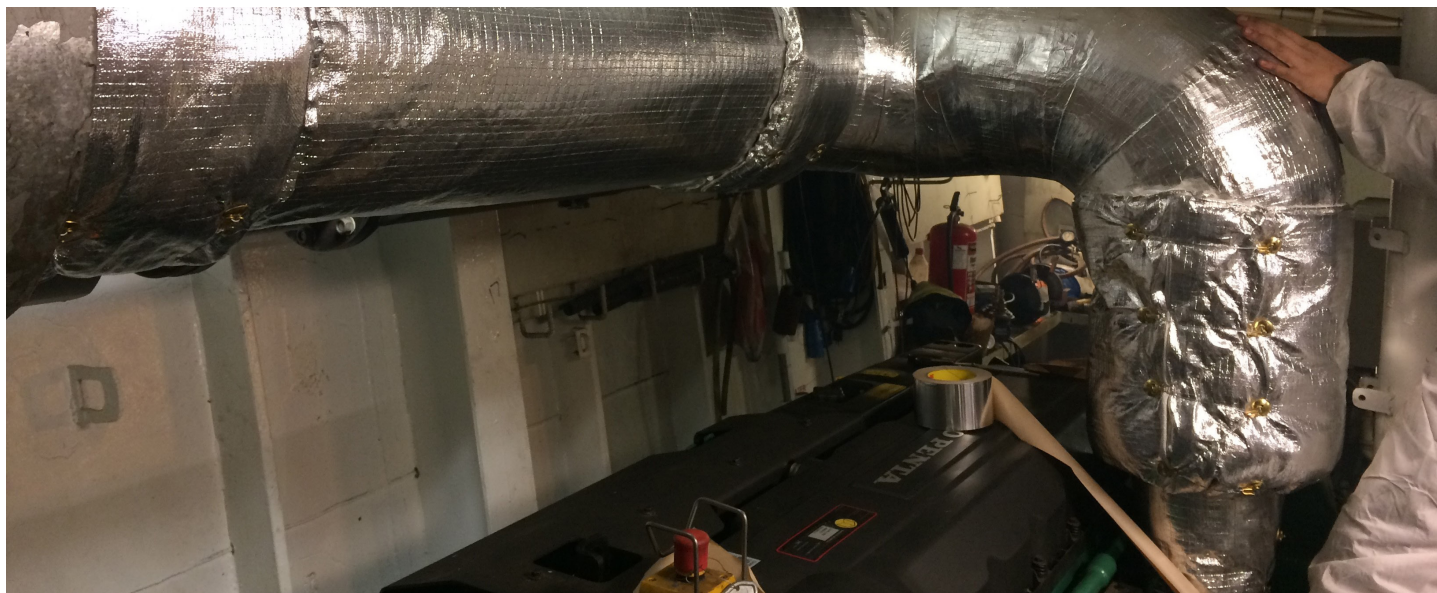
Insulation to Aux machinery was renewed and jackets fitted to the flanges and compensators. All these are SOLAS compliant.

The engine and machinery spaces were upgraded and main and Auxiliary Engine exhausts insulation was renewed.

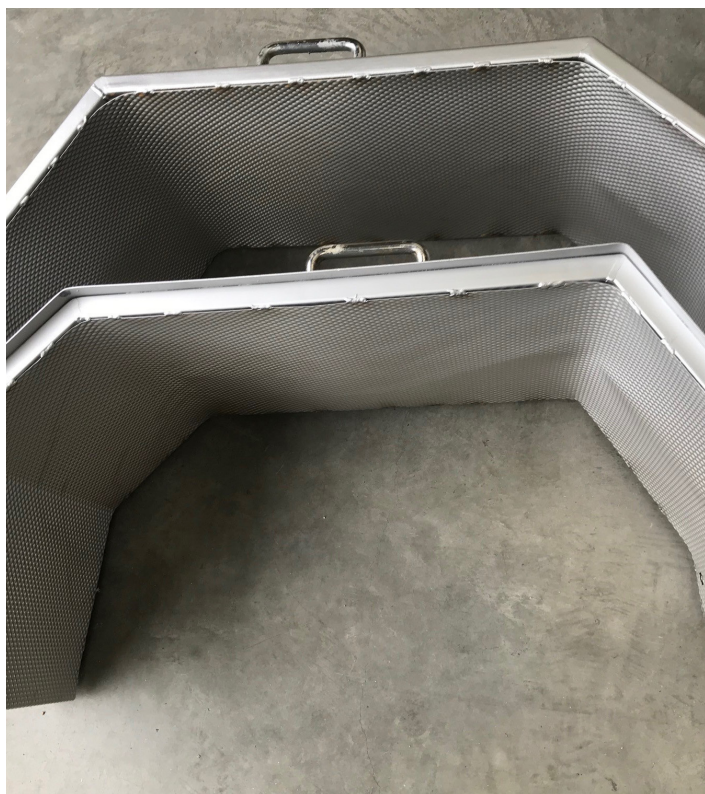
Renewed and refurbished heat shields.

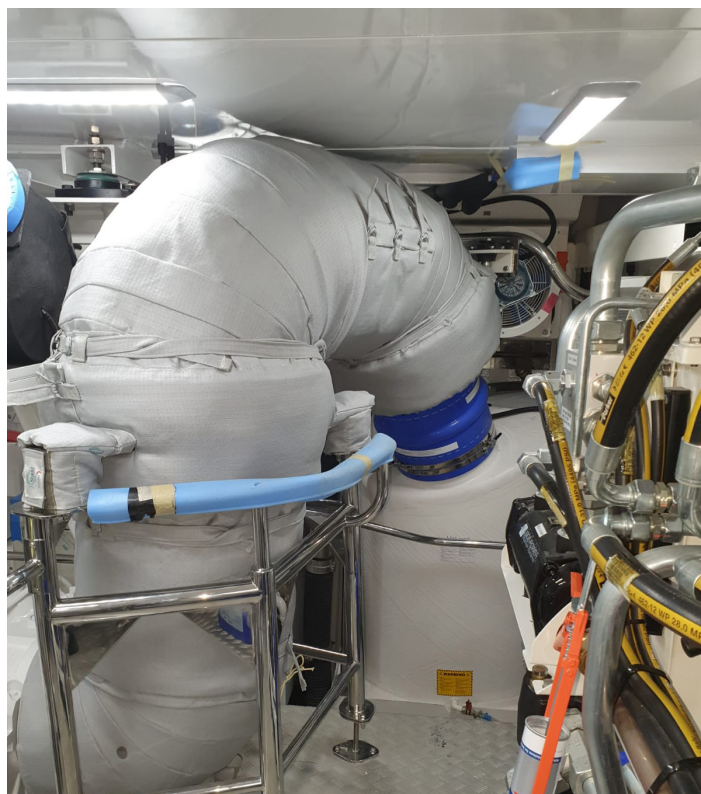
Replacement insulation jackets to exhausts with coated oil resistant glass cloth to comply with SOLAS flammable fluid containment.

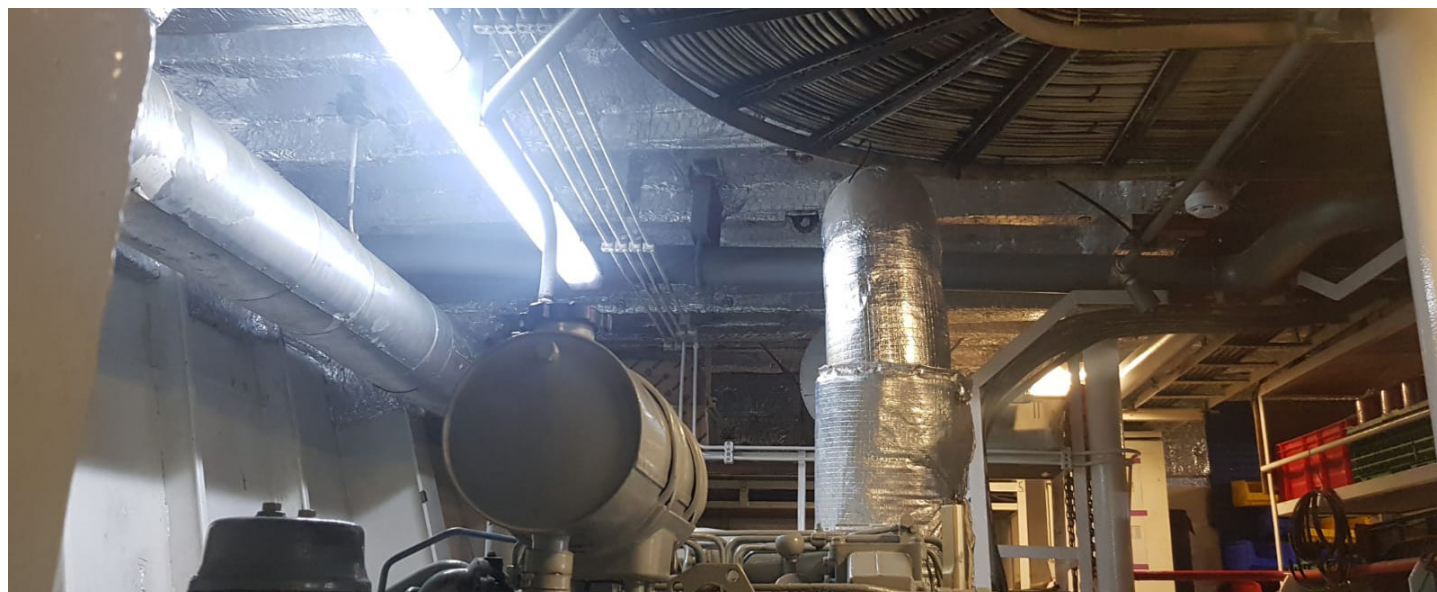
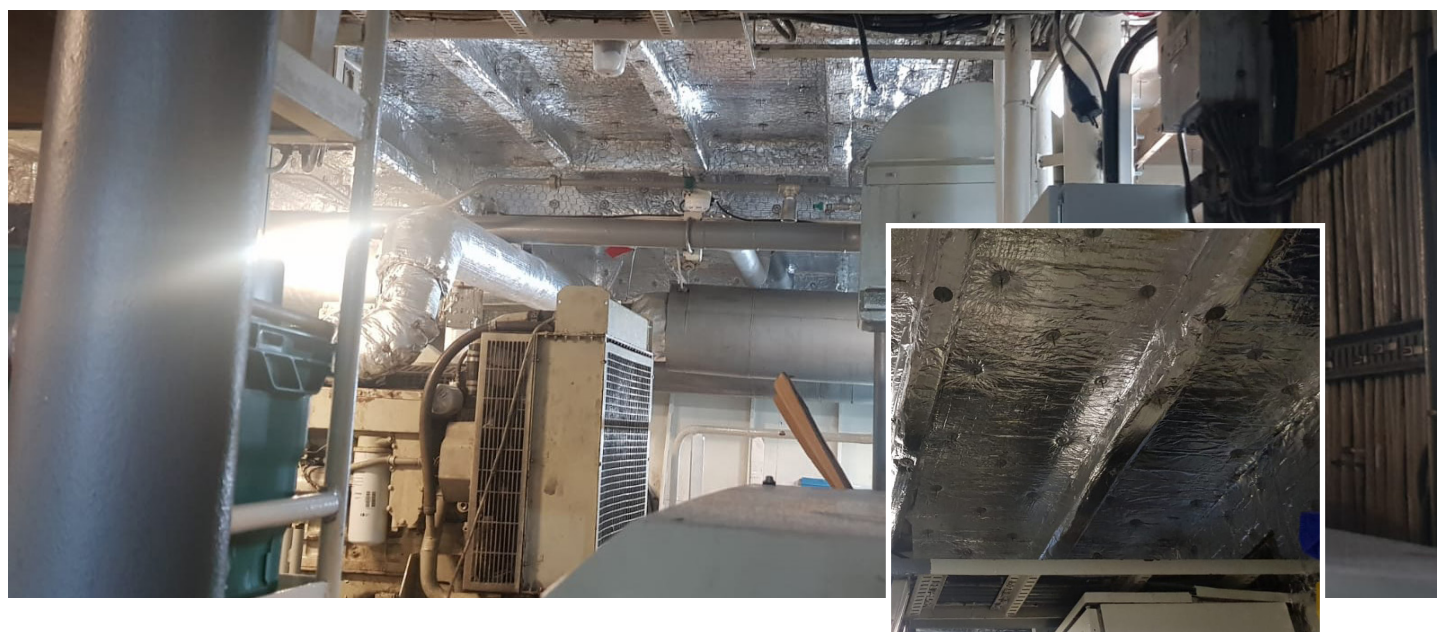
Engine Room Deck-head A60 insulation

This application was a high density mineral wool throughout the engine and machinery spaces with pipe and electrical penetrations, stiffeners and beams, installed wiring, trunkings and other installations which made the application complex.

An additional layer of wire mesh was also applied which reduces the risk of system failure.

The installation in this area was challenging, requiring a team effort to access areas and ensure that the potentially life-saving application was installed correctly and securely.
