Asbestos Case Study

Treviglas Academy - Newquay

Treviglas Academy, Newquay

The Shield Asbestos Services Truro branch was contracted by Kier Group to undertake asbestos removal and soft strip work at Treviglas Academy in Newquay, Cornwall. The project involved the phased refurbishment of the entire Academy premises whilst the school remained operational.

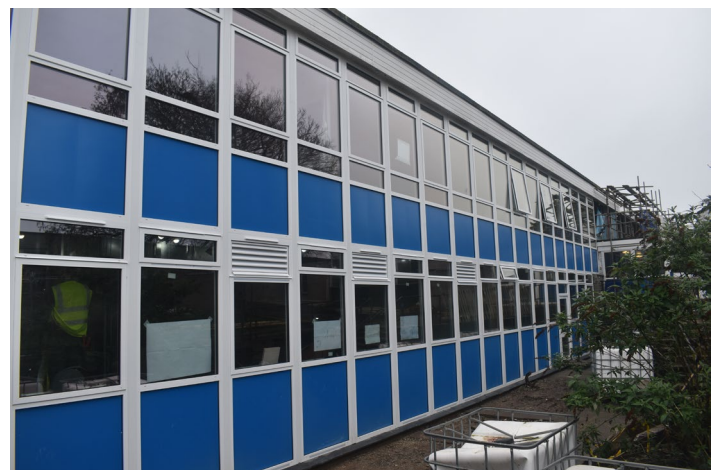
External view of window mullions prior to erection of asbestos enclosure

All licenced works were carried out and removed under fully controlled conditions, within pre-erected asbestos enclosures after satisfactory smoke testing. There were eight separate enclosures within each phase of work. Suppression of the material was undertaken in line with Shield SOPs before being removed, bagged/wrapped and removed from the enclosures into onsite skips in line with Shield SOPs ASP053, ASP054 & ASP055.

Shield remedial works included the removal of both asbestos-licensed and non-licensed asbestos materials throughout the various phased works. These included but were not limited to AIB ceilings, mullions, packers, contaminated ceiling voids, pipe insulation, textured coatings to walls, ceilings and bitumen floor tiles and screed etc.

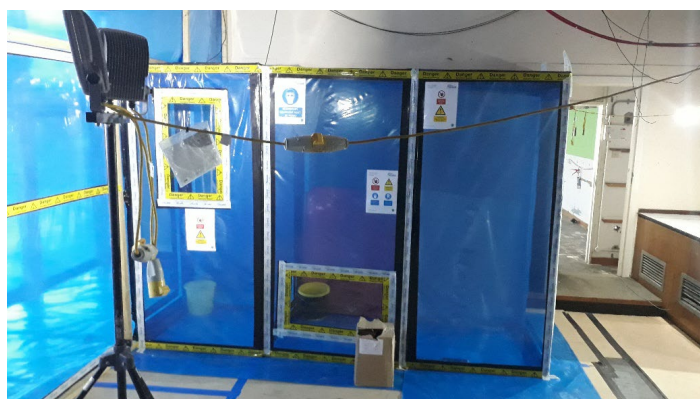
Example of airlock to live asbestos enclosure

All licenced works were carried out and removed under fully controlled conditions, within pre-erected asbestos enclosures after satisfactory smoke testing. There were eight separate enclosures within each phase of work. Suppression of the material was undertaken in line with Shield SOPs before being removed, bagged/wrapped and removed from the enclosures into onsite skips in line with Shield SOPs ASP053, ASP054 & ASP055.

Upon completion of all removal and enclosure decontamination work, the enclosures were inspected by our onsite supervisor, who carried out a pre-analyst inspection in line with our company policy AR125 Analyst Enclosure Handover Process Form. Before being offered up to the client's nominated analytical contractor to commence the 4-stage clearance procedure.

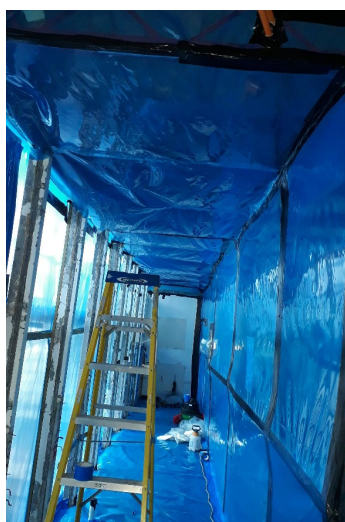
Left: Enclosure preparation to external mullions

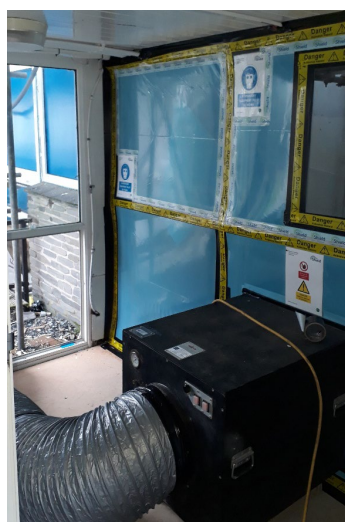
Right: Example of neagive pressure units to live enclosure
