Asbestos Case Study

Asbestos Chalcroft Business Park

Chalcroft Business Park, Southampton

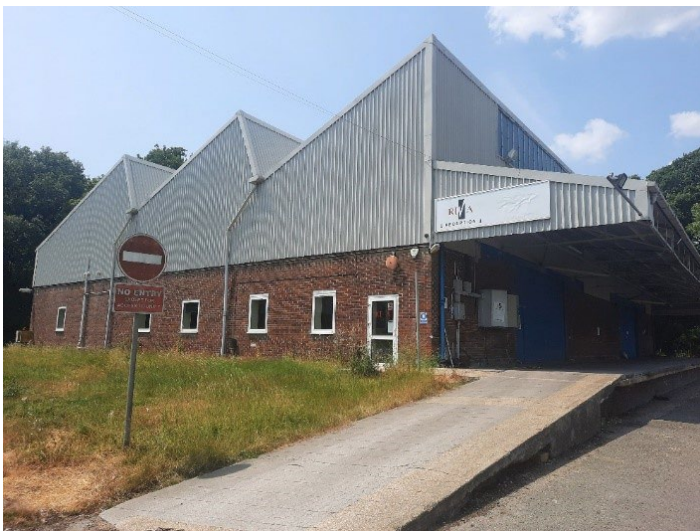
Units 6 & 7, Chalcroft Business Park

As part of the works, Shield operatives worked under fully controlled conditions to carry out the removal of the Thermal Insulation residue to the internal perimeter walls and high-level steel framework. All works were carried out in accordance with the Control of Asbestos Regulations 2012 (CAR2012), and the Licenced Contractors Guide HSG247.

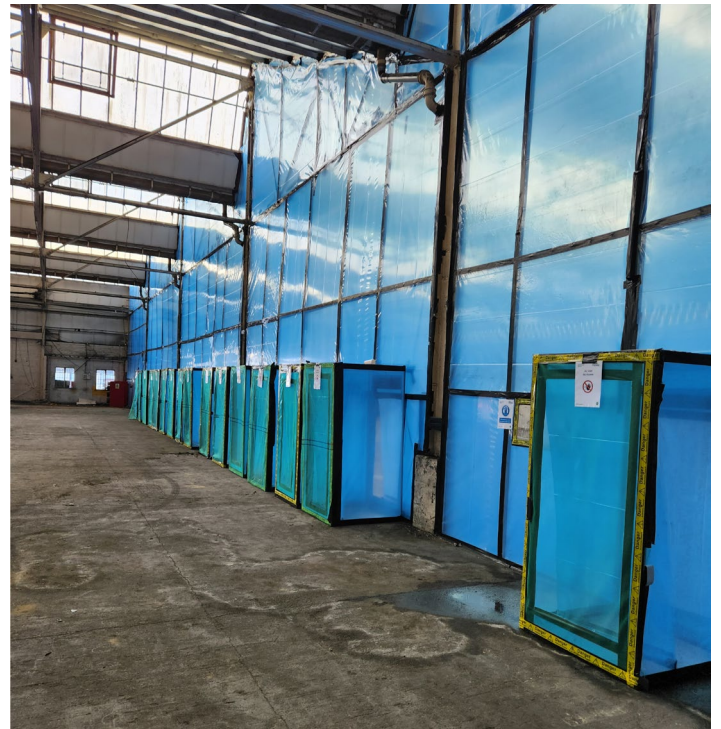
Due to the size of the Units, the areas had to be split into separate enclosures

Due to the size of the areas, ten 10,000 NPUs were used per area.
